CLOSED  
BARRERAS ABISAGRADAS

grupo  
centrocibic

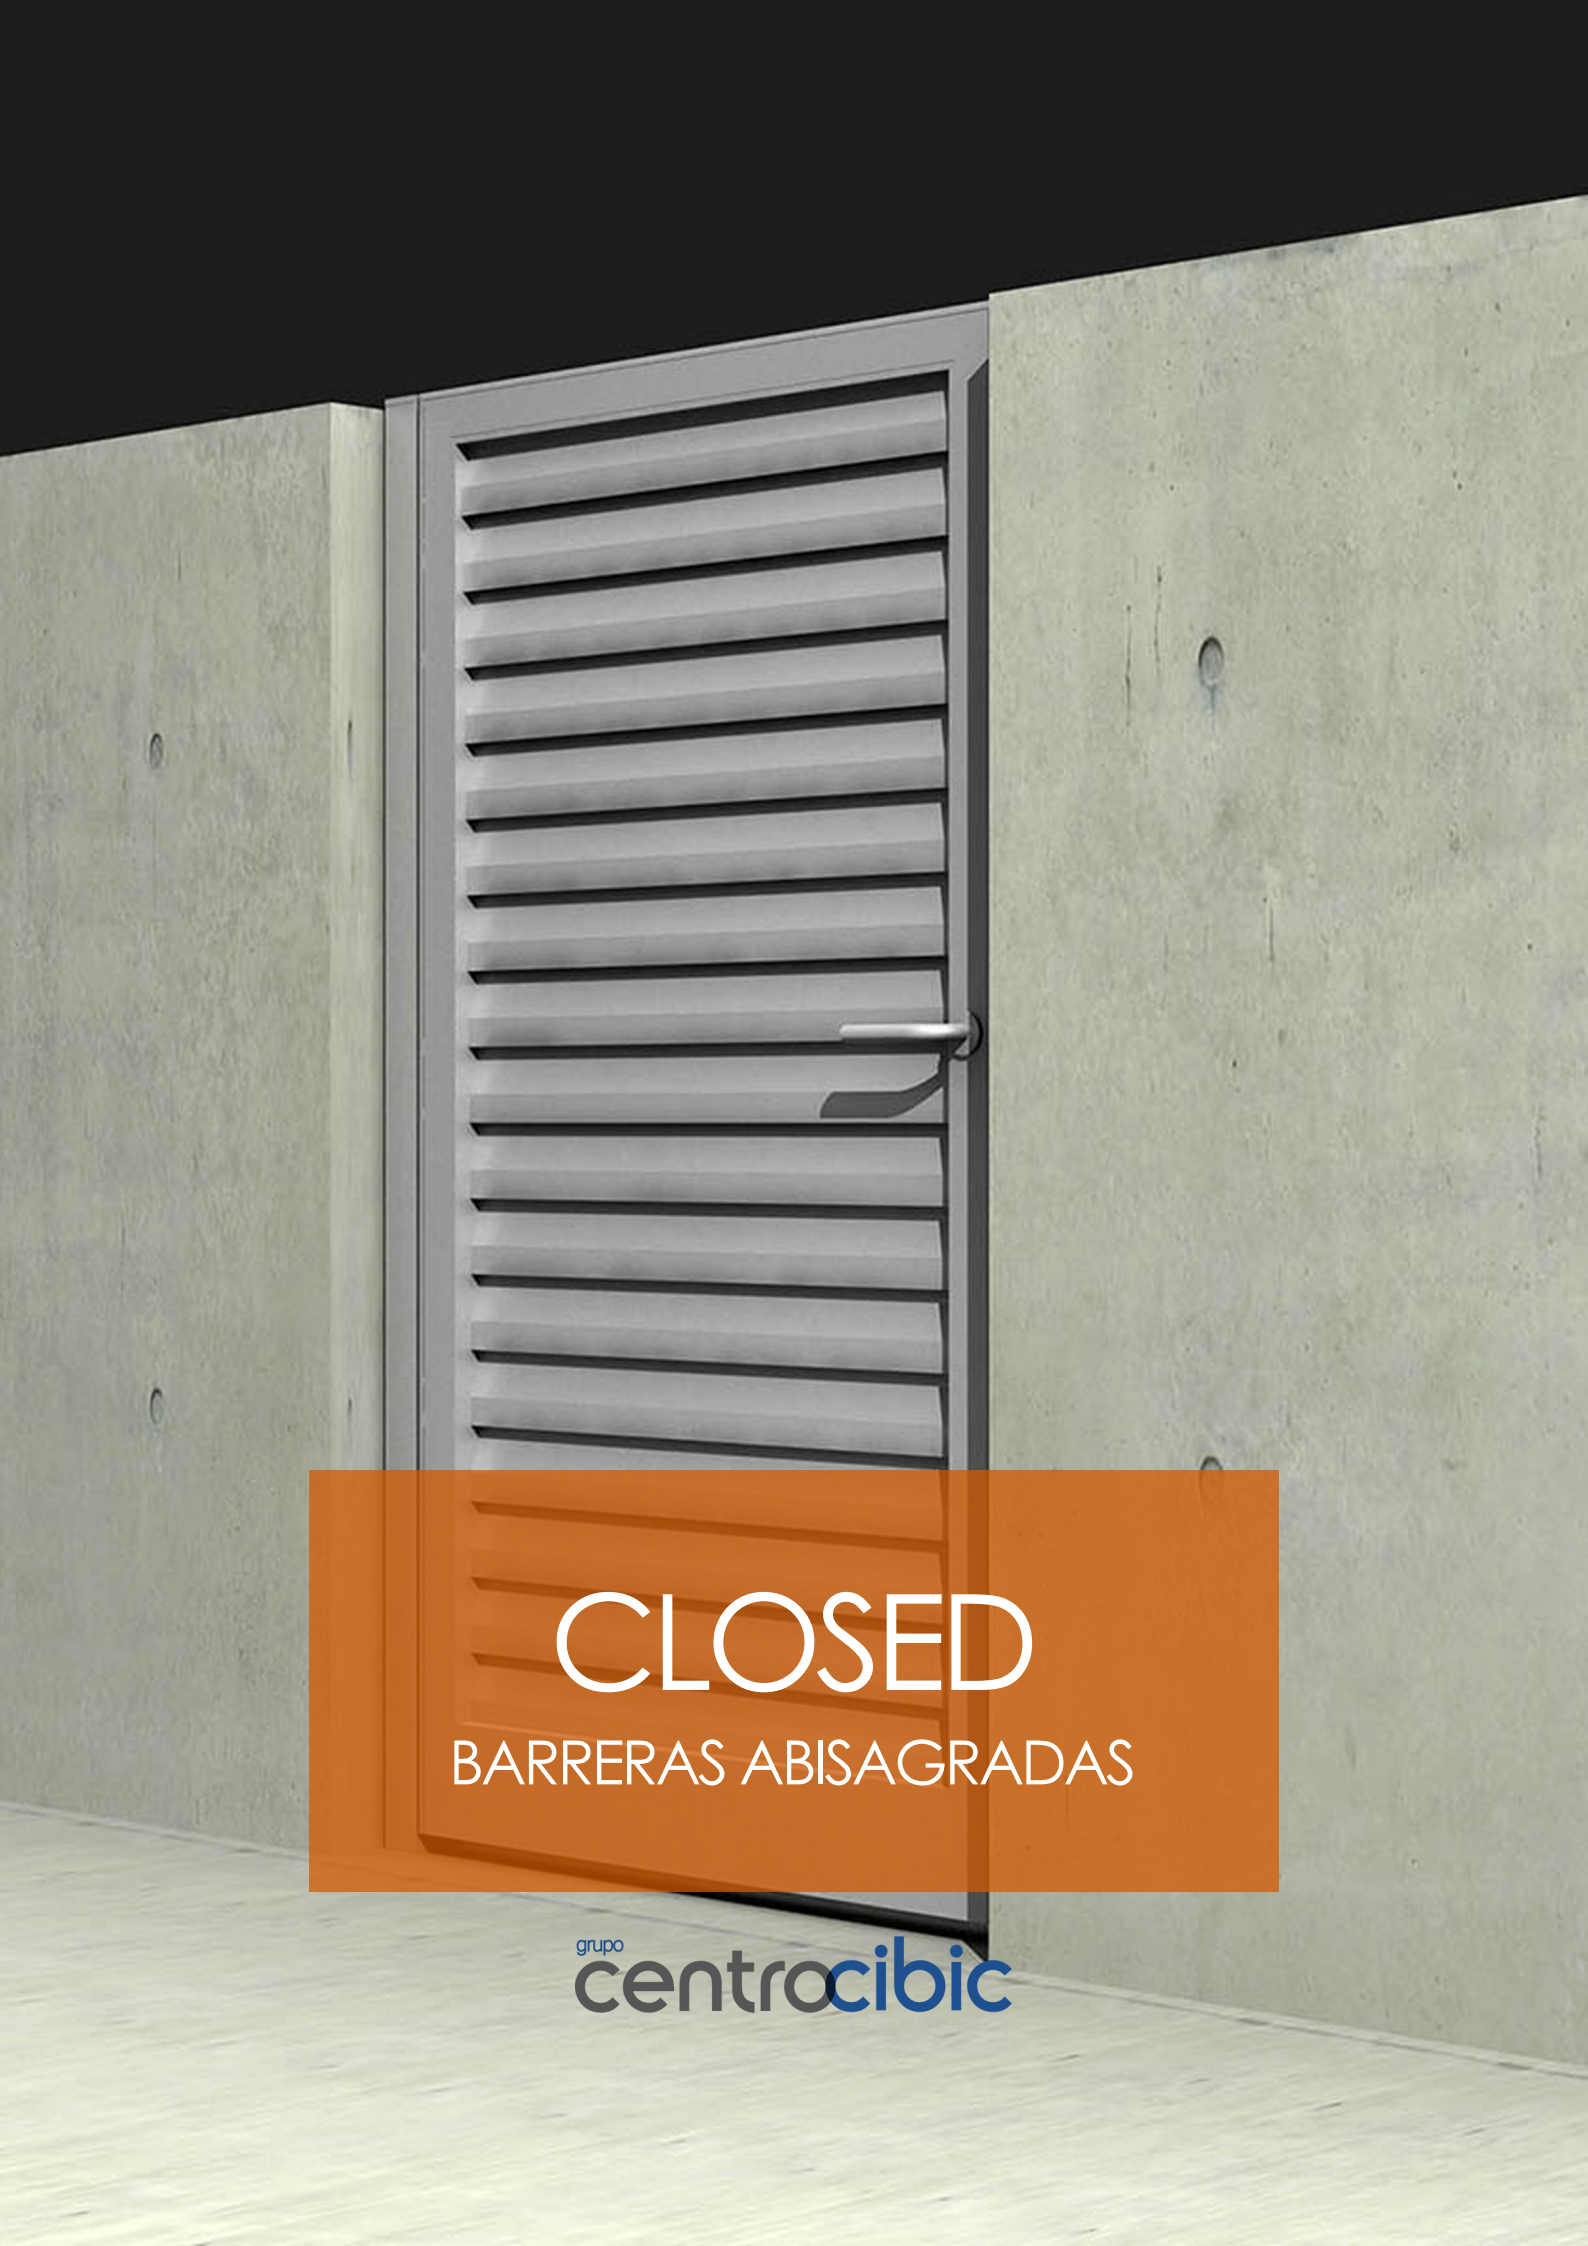
A photograph of a closed grey louvered door set into a concrete wall. The door has horizontal slats and a silver handle. The wall is made of light-colored concrete with some visible texture and small circular indentations. The floor is a light-colored, textured surface.

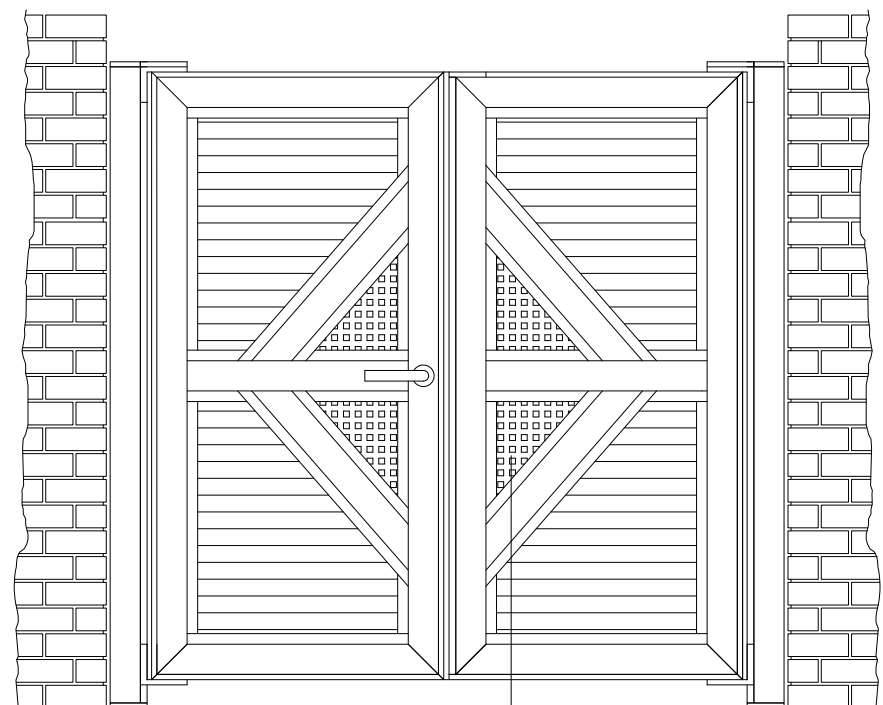
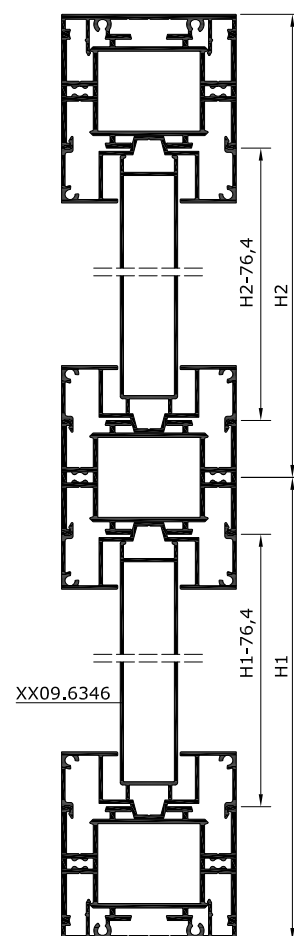
SECCIÓN VERTICAL

| CONFIGURACIÓN | |
| MARCO | Opción M05 |
| HOJA | Superior HSUP15 |
| | Inferior HINF15 |
| INVERSOR | INV2 |
| BISAGRA | VA70.0340 |

X220BCK

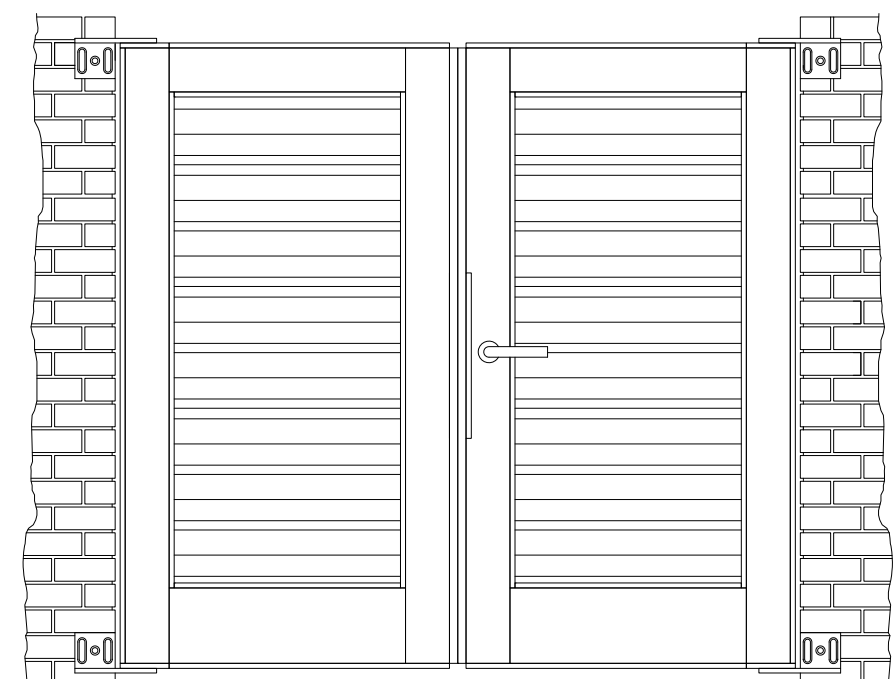
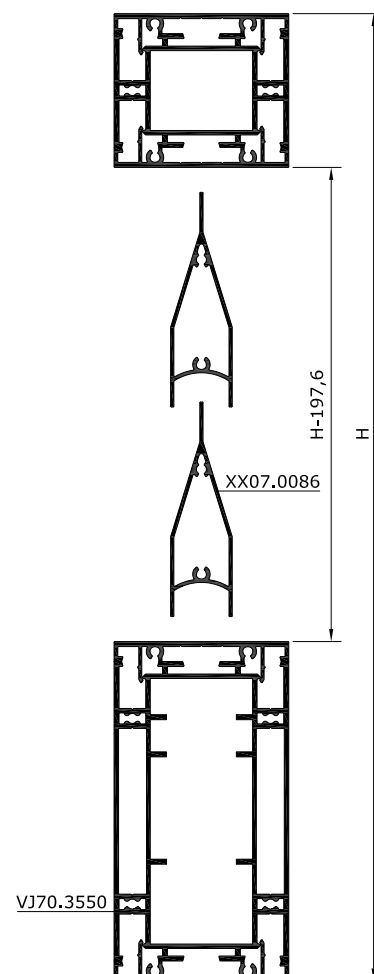
SECCIÓN VERTICAL

| CONFIGURACIÓN | |
| <b>MARCO</b> | Opción M02 |
| <b>HOJA</b> | Superior HSUP1 |
| | Inferior HINF3 |
| <b>INVERSOR</b> | INV3 |
| <b>BISAGRA</b> | VA70.0740 |

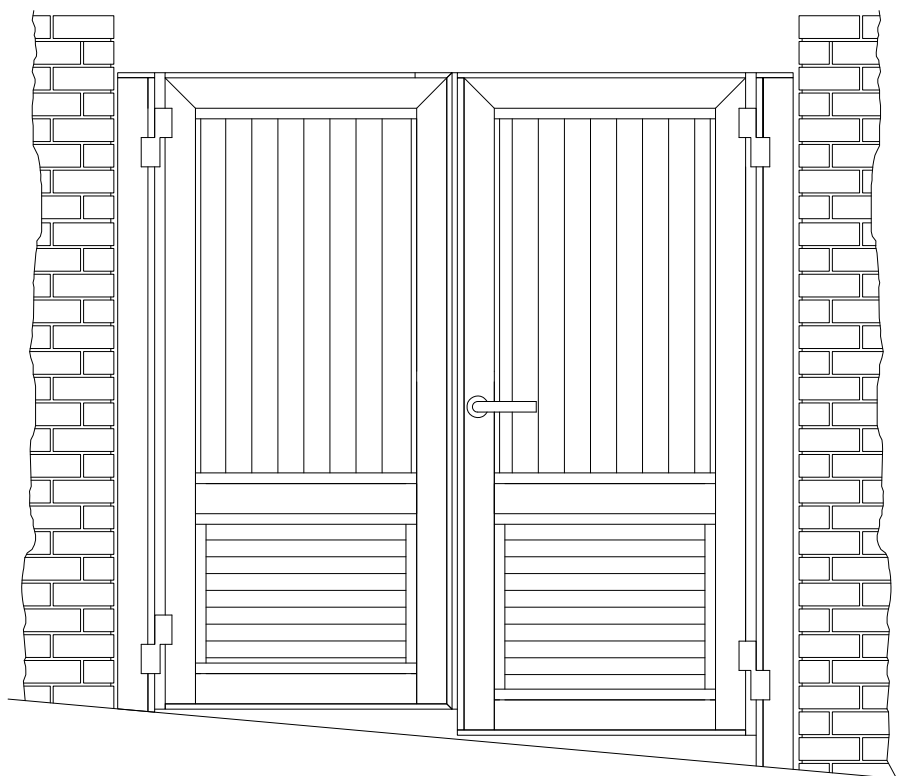
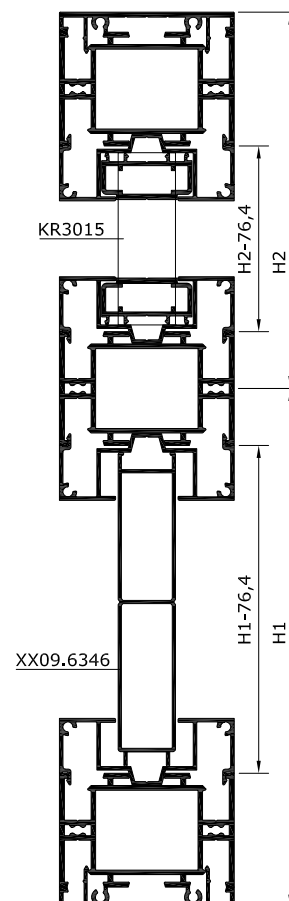
SECCIÓN VERTICAL

| CONFIGURACIÓN | |
| MARCO | Opción M21 |
| HOJA | Superior HSUP5 |
| | Inferior HINF1 |
| INVERSOR | INV2 |
| BISAGRA | VA70.0700 |

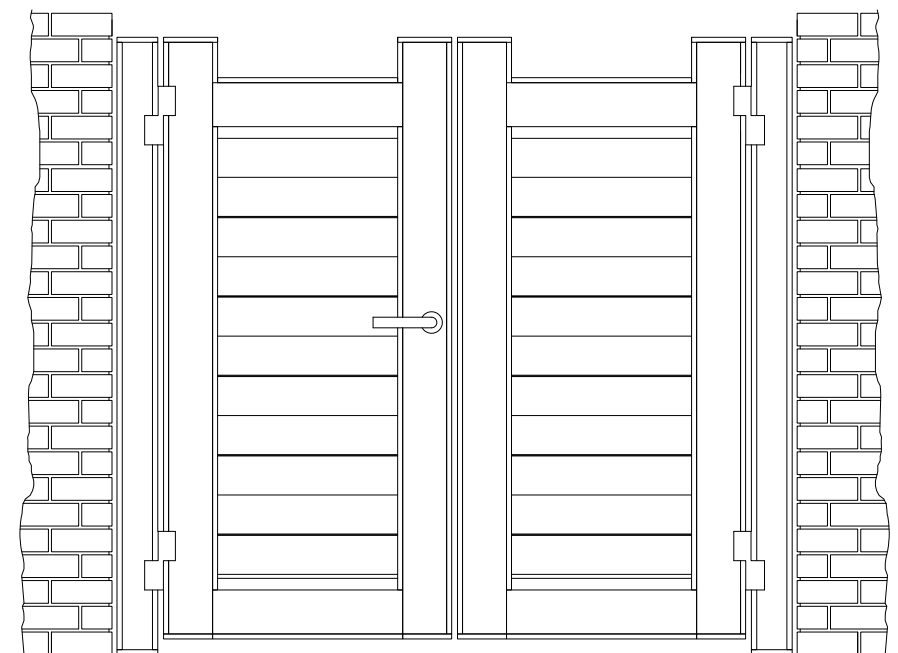
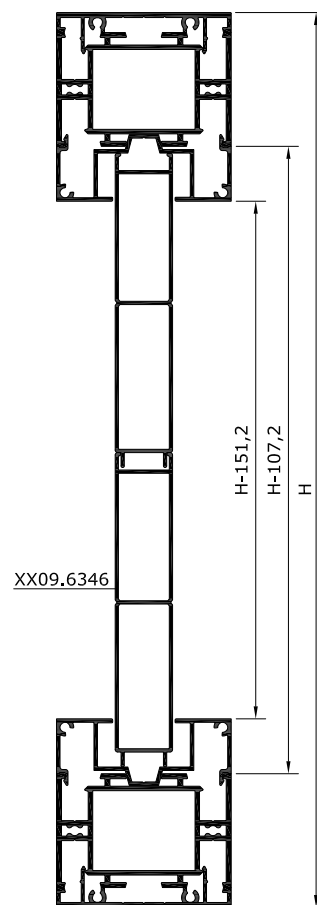
SECCIÓN VERTICAL

| CONFIGURACIÓN | |
| MARCO | Opción M03 |
| HOJA | Superior HSUP2 |
| | Inferior HINF1 |
| INVERSOR | INV1 |
| BISAGRA | VA70.0710 |

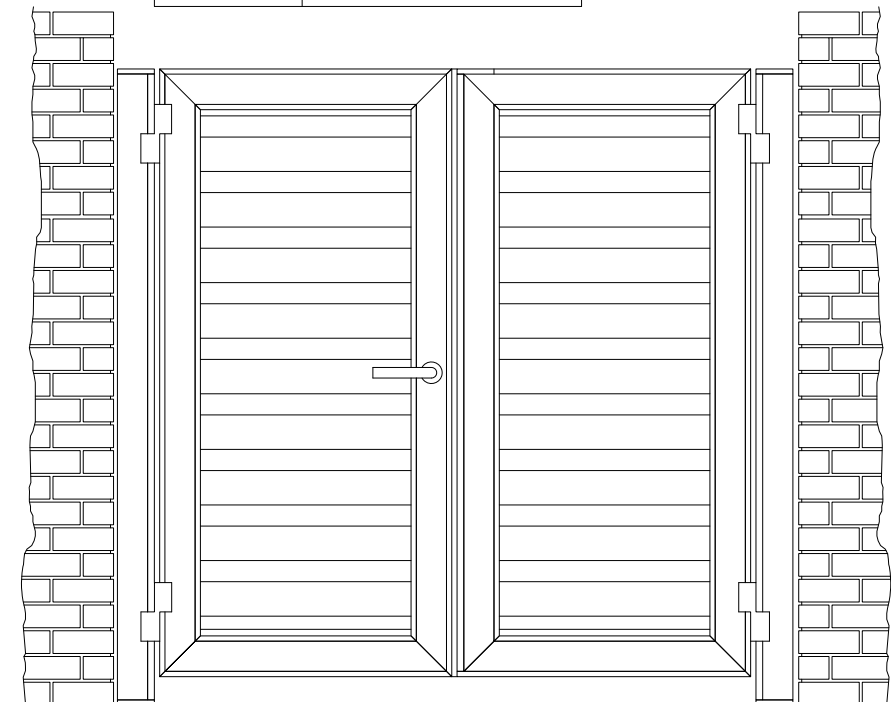
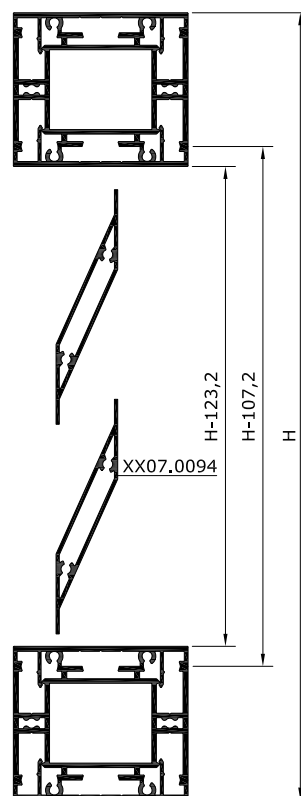
SECCIÓN VERTICAL

| CONFIGURACIÓN | |
| <b>MARCO</b> | Opción M04 |
| <b>HOJA</b> | Superior HSUP5 |
| | Inferior HINF5 |
| <b>INVERSOR</b> | INV5 |
| <b>BISAGRA</b> | VA70.0720 |
